**US Army Corps
of Engineers®**
Engineer Research and
Development Center

A Survey of the Invasive Aquatic and Riparian Plants of the Lower Rio Grande, 2004

September 2005

Final report

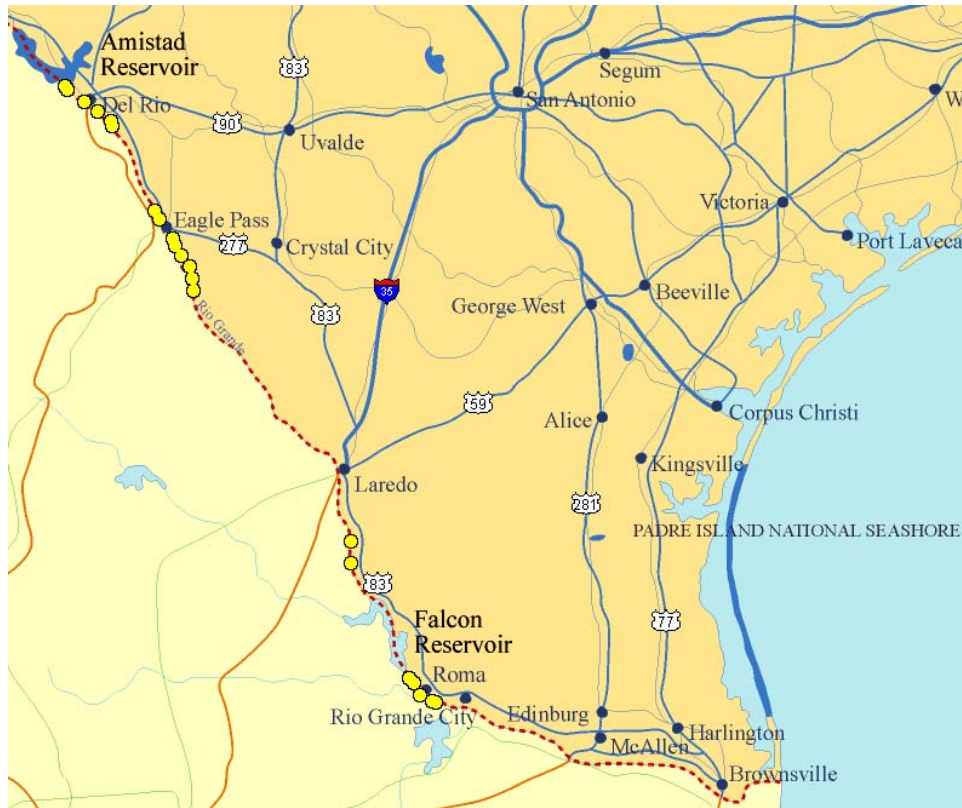
Figure 1. Areas of the Rio Grande sampled during 2003 and 2004

Between 16 and 20 August 2004, seven sites on the Rio Grande were surveyed via airboat from below Amistad Reservoir to 25 river miles below Falcon Reservoir (Figure 1). The 2004 survey was conducted to reassess hydrilla sites that were discovered during the 2003 survey (Owens et al. 2005), to determine spread, and to identify new infestations of hydrilla and other invasive aquatic and riparian species. All sites, except for Indio (boat trouble), were reassessed during the 2004 survey and a new portion of the river (approximately 15 river miles below Laredo) was added. Also, the lower region of the Maverick Irrigation District canal around Laredo was surveyed. At all hydrilla sites, samples were collected to determine presence of the larval stages of the introduced insect biological control agents *Hydrellia pakistanae* and *H. balciunasi*. Samples of Eurasian watermilfoil also were collected to check for native insect herbivores and fungal pathogens.

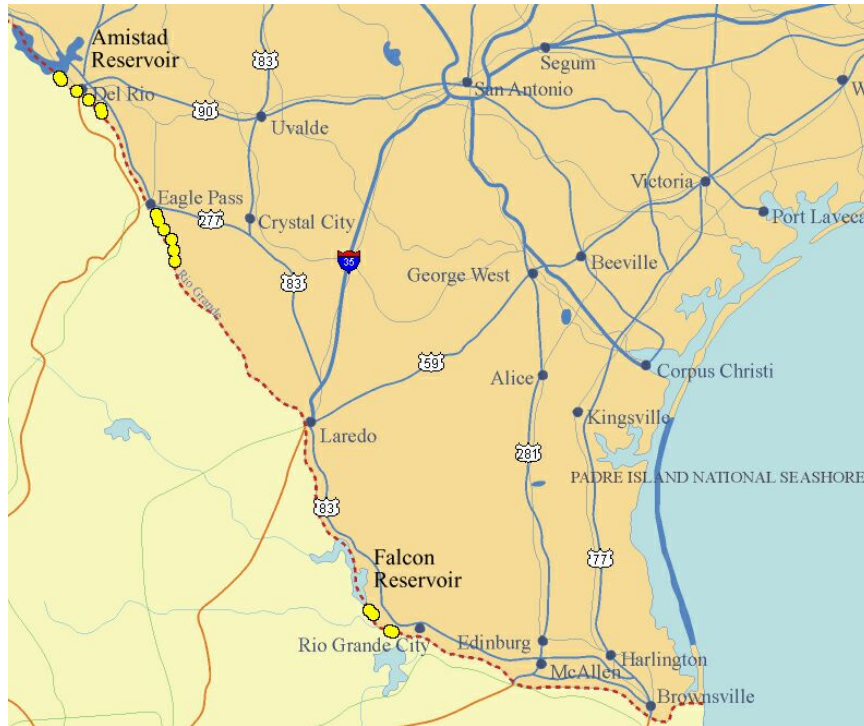
Figure 2. Sites on the Rio Grande where hydrilla was observed during 2003 surveys

Several small infestations of hydrilla were observed during the 2003 survey in the area of the river accessed from Del Rio, TX (Figure 2). These hydrilla sites were reassessed in 2004 and generally found to have expanded in size. Also, numerous new sites were located, especially immediately below Amistad Dam (Figure 3). Extensive hydrilla infestations occur in Amistad Reservoir, thus providing the propagule source for fragment and turion dispersal into the river (Figure 4).

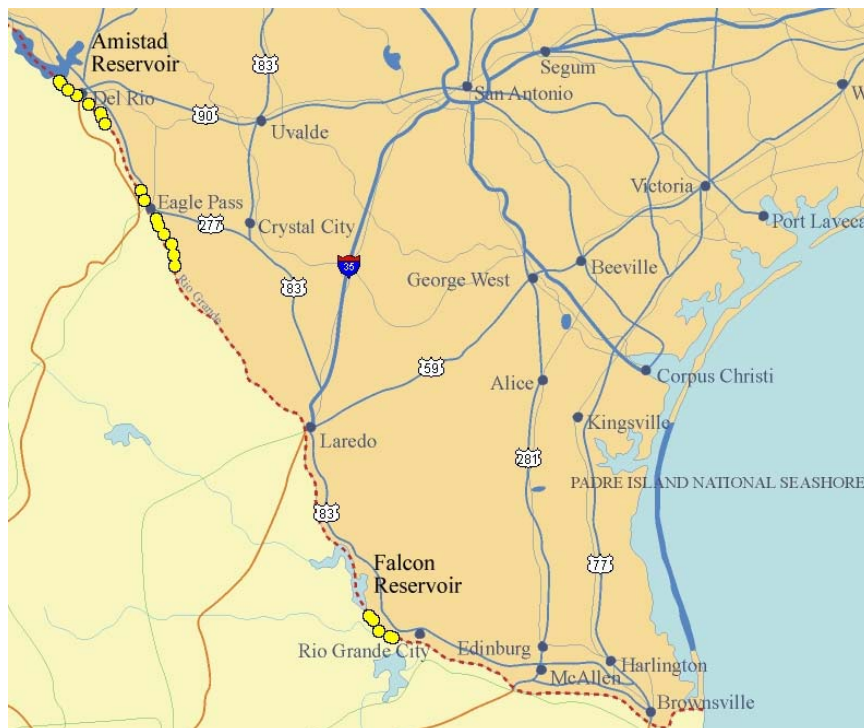
Figure 3. Areas of the Rio Grande surveyed where hydrilla was observed in 2004

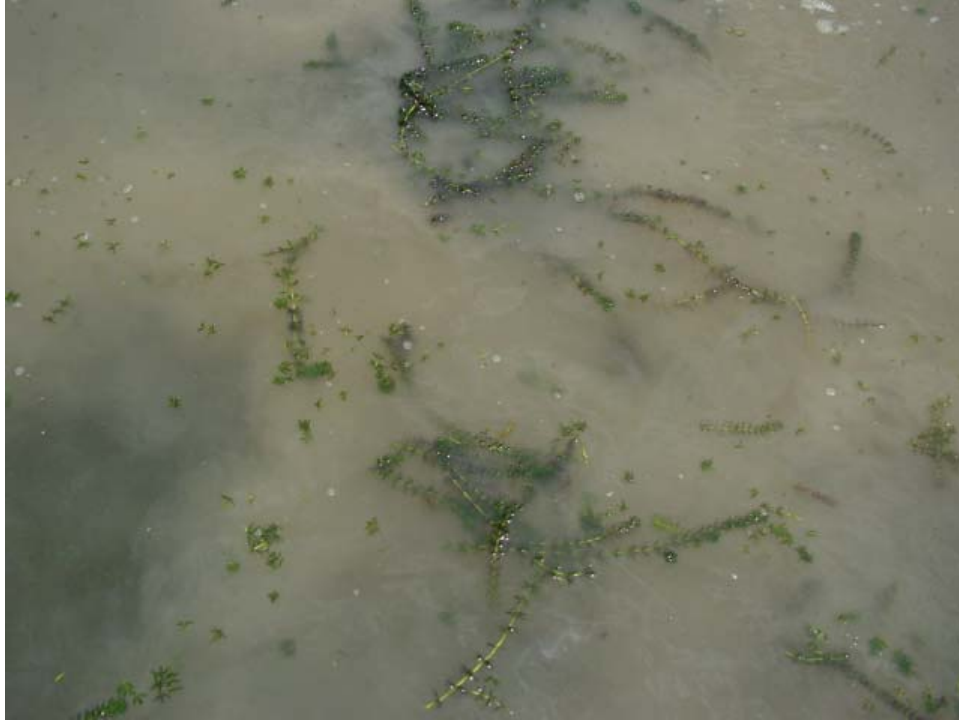
Figure 4. Hydrilla fragments floating in the Rio Grande

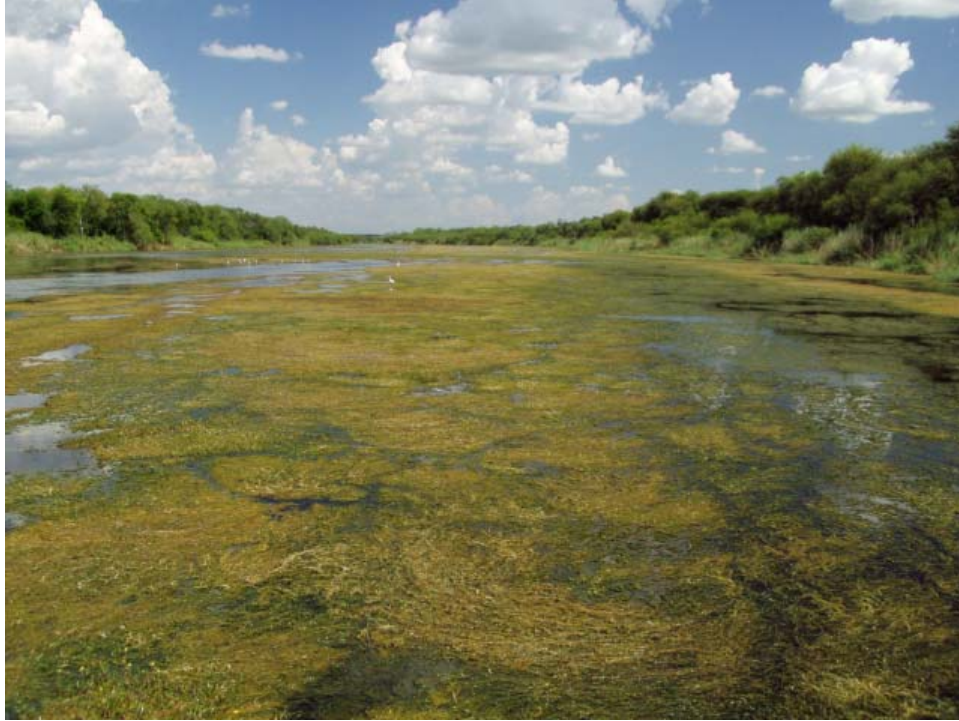
Because “topped out” hydrilla infestations have been observed in Falcon Reservoir and in the river below the reservoir, the stretch of the river from Roma, TX, to the reservoir was extensively surveyed. Hydrilla was observed at every river mile point for 25 miles below Falcon Reservoir, and at many sites the hydrilla reached bank to bank (Figure 5). In addition to observing hydrilla, the plants were sampled for the presence of the biocontrol agents *Hydrellia pakistanae* and *H. balciunasi*. Releases of these biocontrol agents have been made on several areas of the river including Roma, Lonesome Dove, and Falcon Reservoir. During the 2004 survey, low numbers of adult *Hydrellia* flies were hand-collected from several hydrilla sites below Falcon Reservoir and larvae were found in the collected hydrilla biomass.

Figure 5. Extensive hydrilla mat at Roma, TX

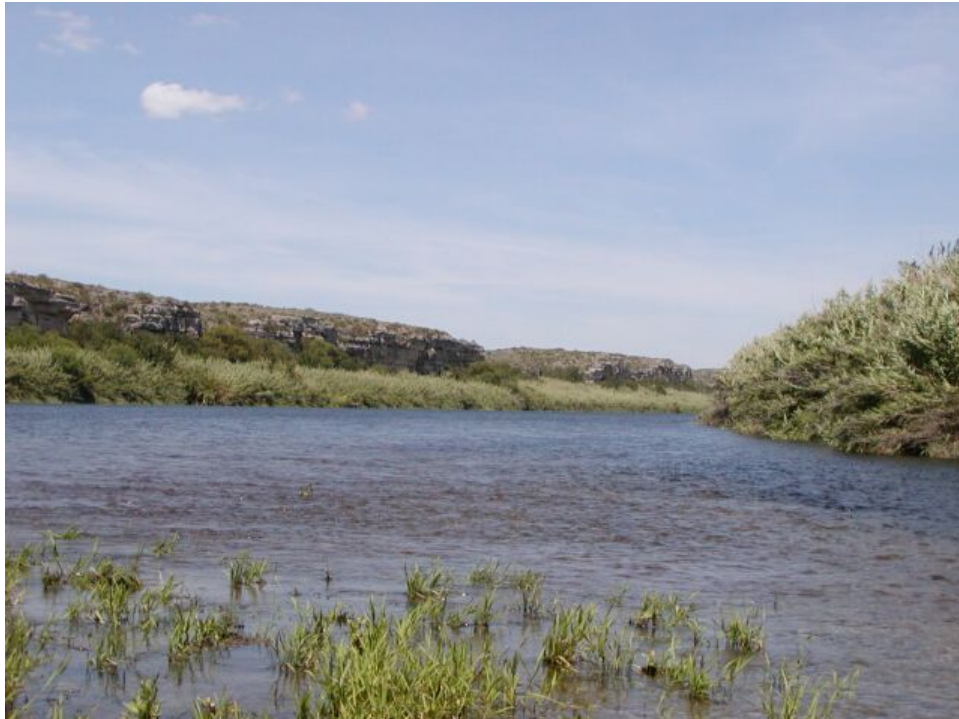
While the main objective of the 2004 survey was to locate and monitor hydrilla infestations in the river, other introduced and potentially damaging plant species were monitored, including giant cane, elephant-ear, Eurasian watermilfoil, parrotfeather, salt cedar, and castorbean. According to data collected during the 2001 (Nibling and Grodowitz 2001) and 2003 (Owens et al. 2005) surveys, extensive stands of giant cane were found from Del Rio to Zapata, TX. Below Zapata, common cane is dominant, although each year more giant cane displaces native riparian and wetland vegetation along the river corridor (Figure 6). More information is available on giant cane from the 2003 report (Owens et al. 2005).

Figure 6. Giant cane infestation on the river

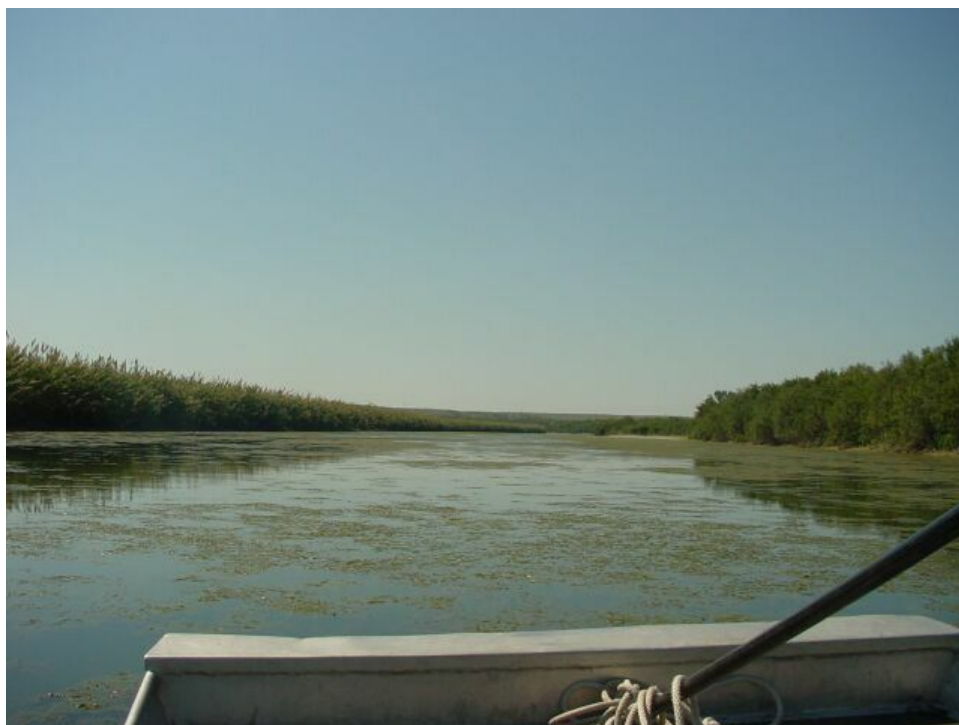
large mats were still visible (Figure 7). Although not observed in 2003, small hydrilla infestations were evident along the edge of Eurasian watermilfoil mats in 2004. Laboratory examination of collected Eurasian watermilfoil samples yielded no native insect herbivores but Mt (*Mycoletodiscus terrestris*), a fungal endophyte, was identified.¹ Evidence from previous studies has shown that Mt can become pathogenic and have a detrimental effect on Eurasian watermilfoil (Shearer 2001).

Figure 7. Bank-to-bank mat of Eurasian watermilfoil immediately upriver of Maverick Irrigation District intake

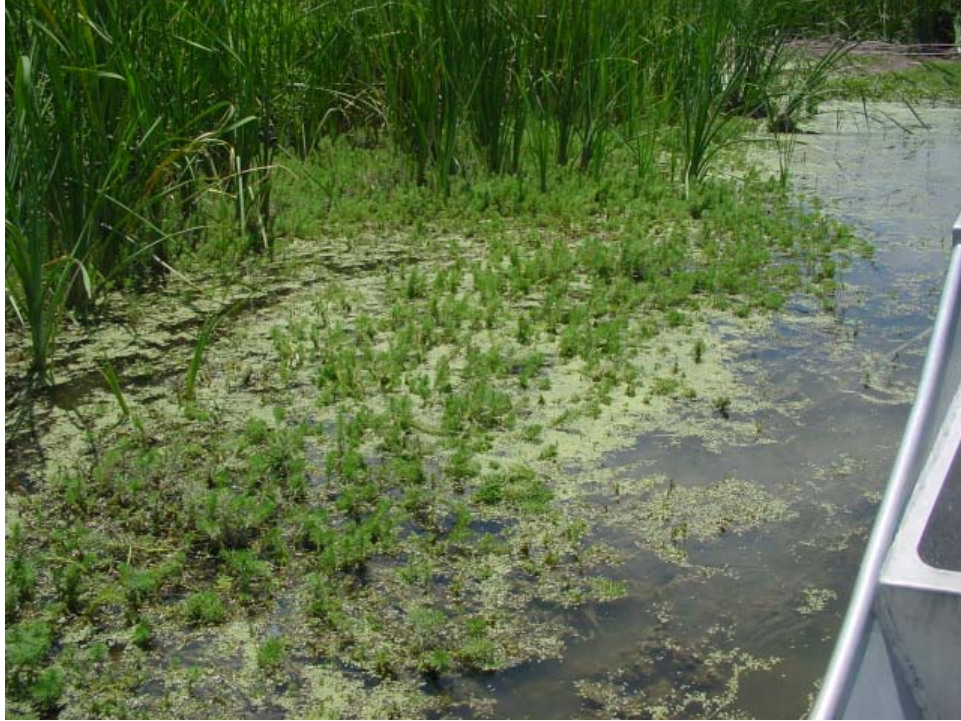
Parrotfeather (Figure 8) and elephant-ear (Figure 9) infestations first discovered during the 2003 survey have spread locally and newly infested areas were observed in 2004. Still at minimal infestation levels in the Rio Grande it should be noted that both of these nonindigenous species have severely affected other river systems in the southwest such as the Colorado River, AZ (Nibling, pers comm.), and the San Marcos River, TX (Owens et al. 2001).

Figure 8. Parrotfeather infestation at Lonesome Dove

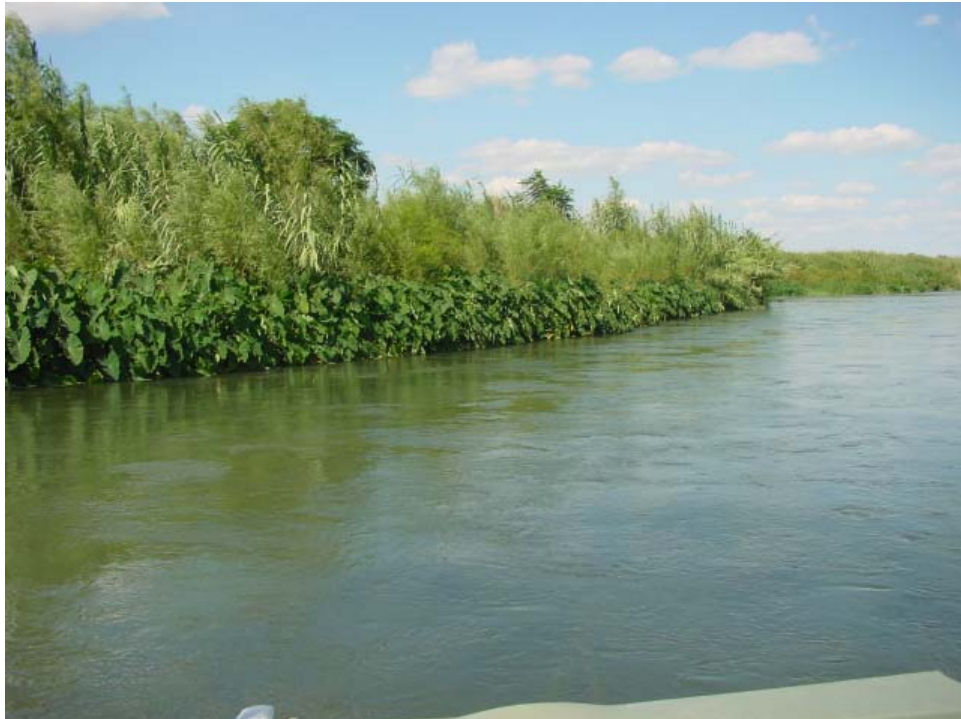
Figure 9. Elephant-ear occupies the niche between giant cane and the river

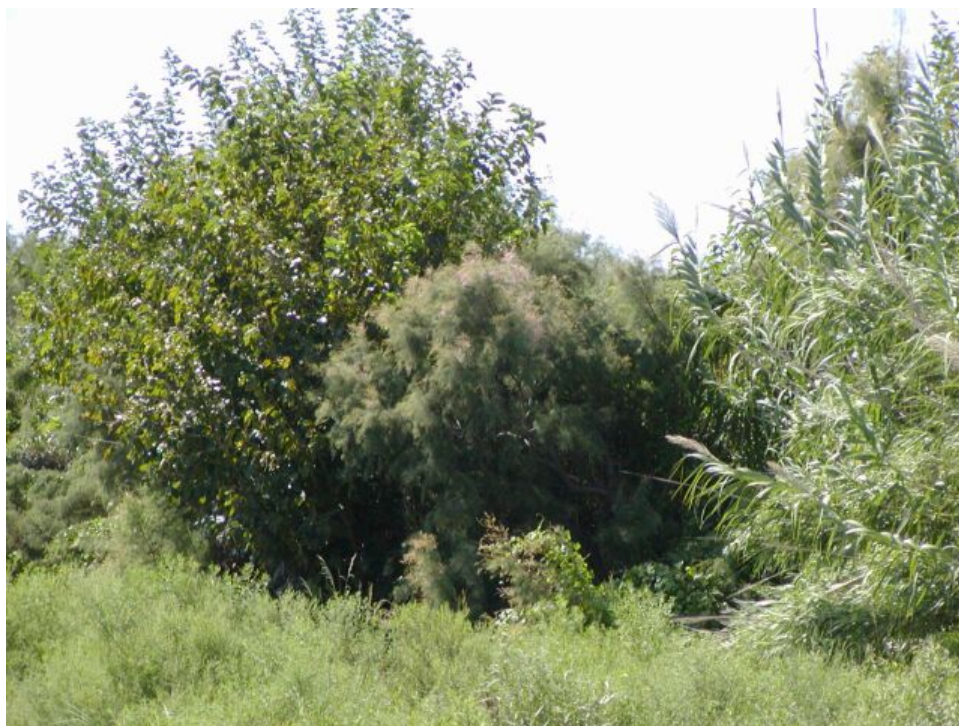
Salt cedar is an extensive problem farther upriver on the Rio Grande and was also observed in the Del Rio and Eagle Pass survey areas in 2003 and 2004. Although the riparian niche is generally occupied by giant cane in this section of the river, it should be noted that more salt cedar was observed in 2004 than the previous year and that this invasive species possesses excellent dispersal mechanisms (Figure 10).

Figure 10. Salt cedar encroaching into riparian regions below Amistad Reservoir

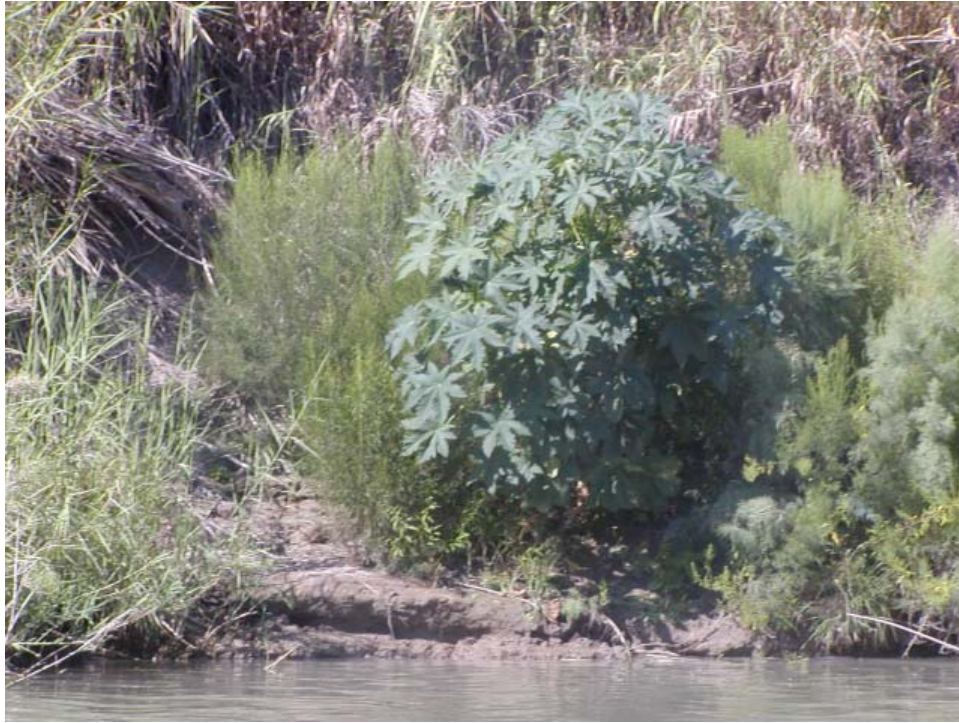
Several castorbean plants were observed below Falcon Reservoir during the 2004 survey (Figure 11). Although the current distribution of this invasive plant is minimal on the river, this nonindigenous shrub/tree can be found in 24 states where it severely affects wetland areas as well as stream and riverbanks and bottomlands in warm climates (www.plants.usda.gov). The seeds from the castorbean are poisonous to people, animals, and insects (www.ansci.cornell.edu/plants/).

Figure 11. Castorbean invasion along the Rio Grande

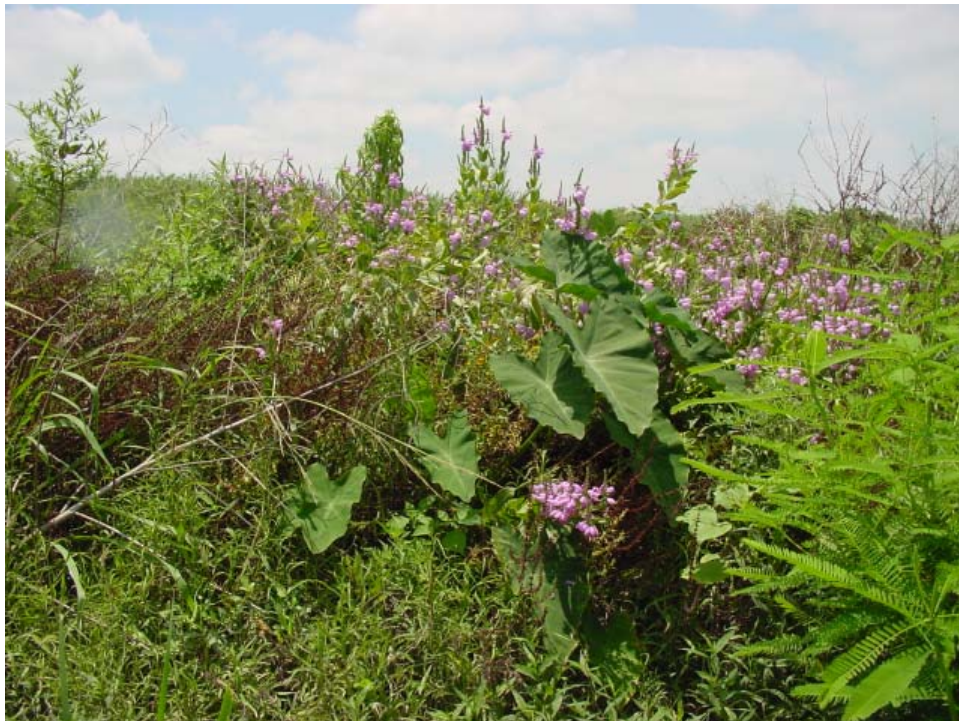
While the same native aquatic and riparian plants were found during the 2004 survey in the Rio Grande as in 2003, four new plants were also identified. The new aquatic plants found in the Del Rio area of the river include southern naiad (*Najas guadalupensis*), small-leaf pondweed (*Potamogeton pusillus*), and horned pondweed (*Zannichellia palustris*) (Table 1). Also, Correll's false dragonhead (*Physostegia correllii* (Lundell) Shinnars), an emergent wetland plant, was tentatively identified (Figure 12). Future visits by Texas Parks and Wildlife personnel will positively identify this wetland species. Considered endangered in Texas, this extant population currently represents a significant discovery.

Figure 12. Tentative discovery of Correll's false dragonhead on the Rio Grande

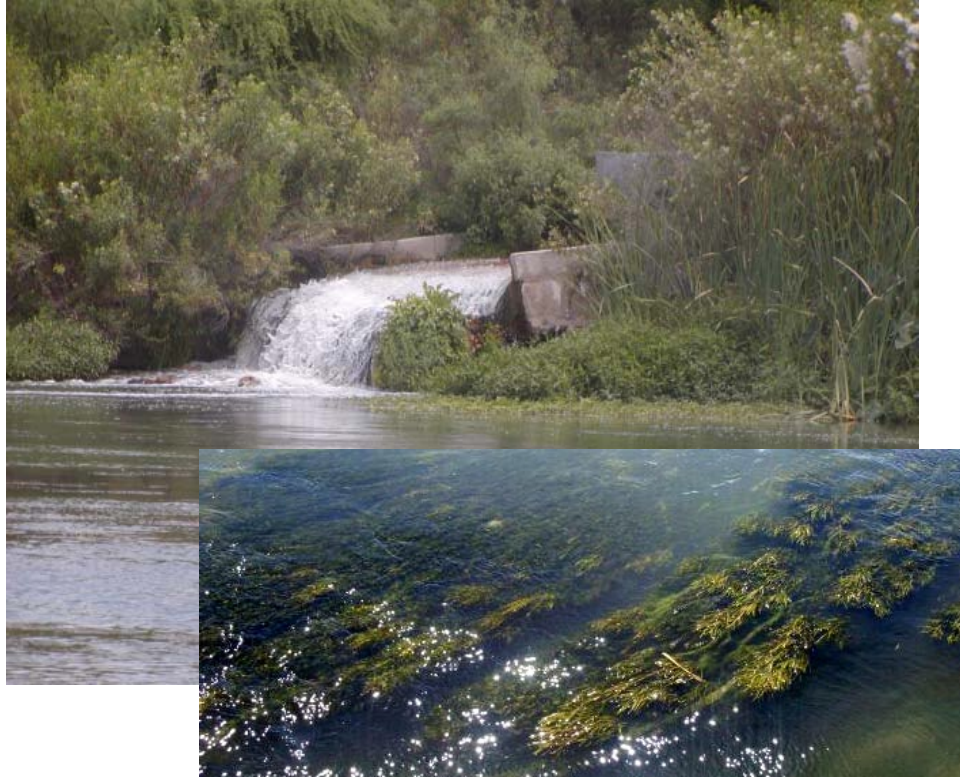
Figure 13. Potential nutrient input from Mexico into the Rio Grande and large intermixed plant bed below outfall

According to the Texas Commission on Environmental Quality, water samples are collected from several sections on the Rio Grande and analyzed for nutrient inputs. Data published in 2003 (Texas Clean Rivers Program) indicated that many areas of the river are high in nutrients, especially nitrogen and phosphorus. It is imperative that water chemistry data be accessed or collected to determine nutrient inputs into the river from Mexico and the United States and their relationship to establishment and spread of invasive plant species. It should be noted that many of the large mats of aquatic vegetation in the river are located immediately below outputs from both Mexico and the United States. Management of many of these aquatic plant species in addition to black moss infestations may be related to some extent by reducing nutrient inputs (Figure 13).
